# CyberX Threat Intelligence

## Rockwell Automation MicroLogix Remote Code Execution

This document details the research that led to the finding of a remote code execution vulnerability on the Allen-Bradley MicroLogix family of controllers from Rockwell Automation.

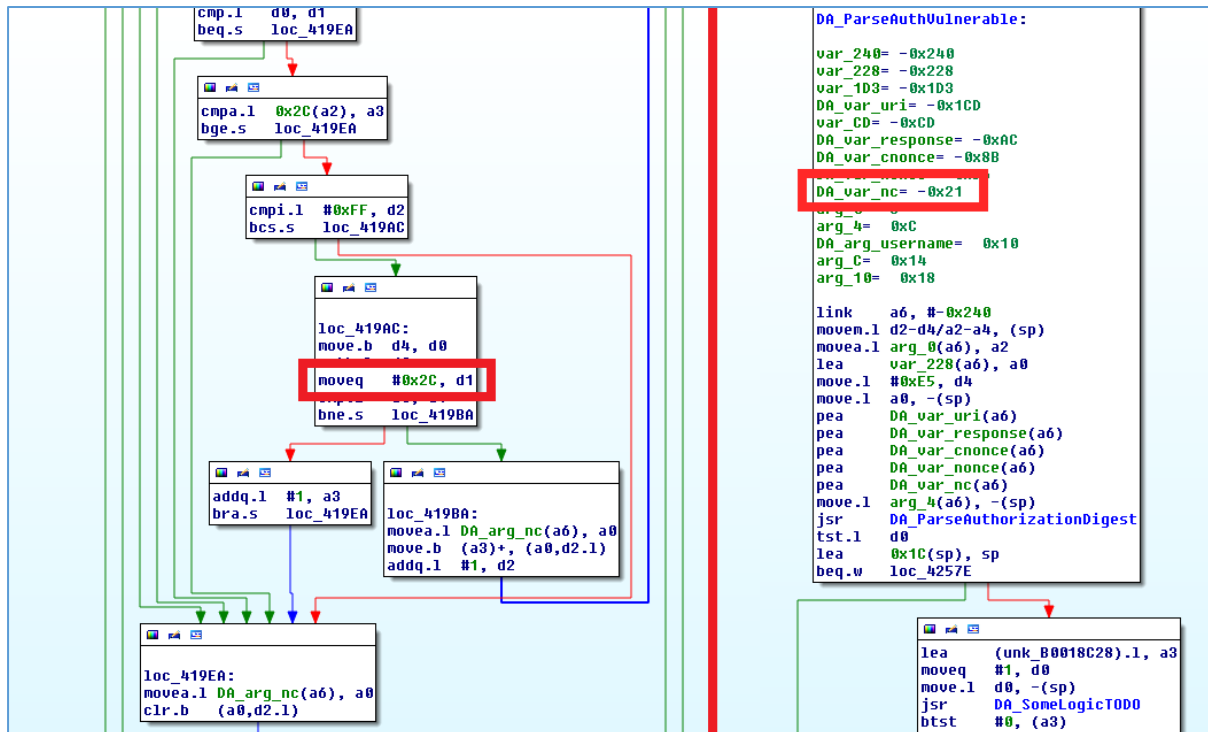
In order for a function to be vulnerable to buffer overflow, it has to copy certain amount of data into a smaller buffer. The function we decided to focus on is responsible for parsing authorization digest header inside the authentication function.

Now that we know which function is vulnerable to buffer overflow, we can send some non-existent addresses and see how the device crashes. However, crashing the device is not enough to prove that it is possible to cause code execution.

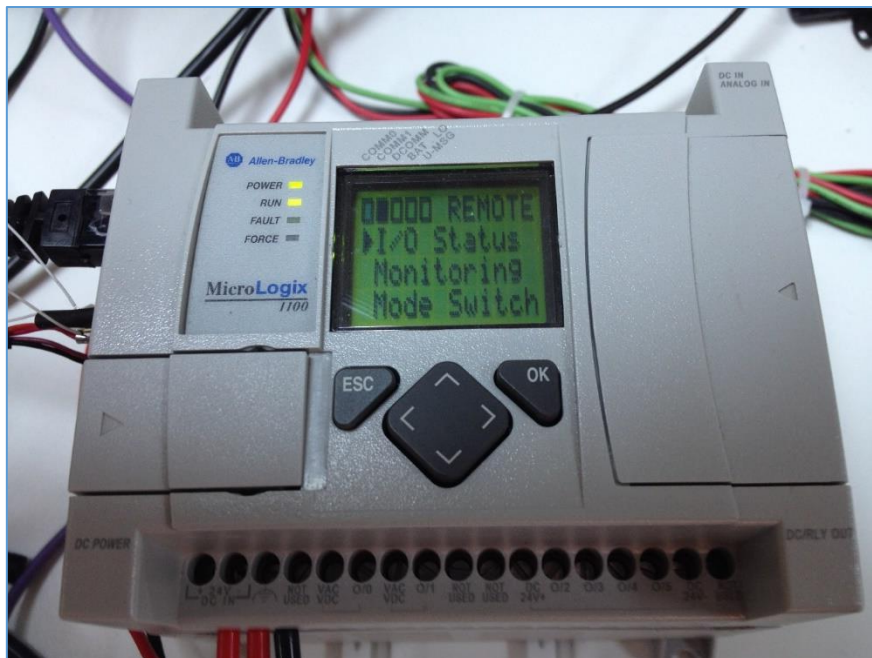
Before running the POC

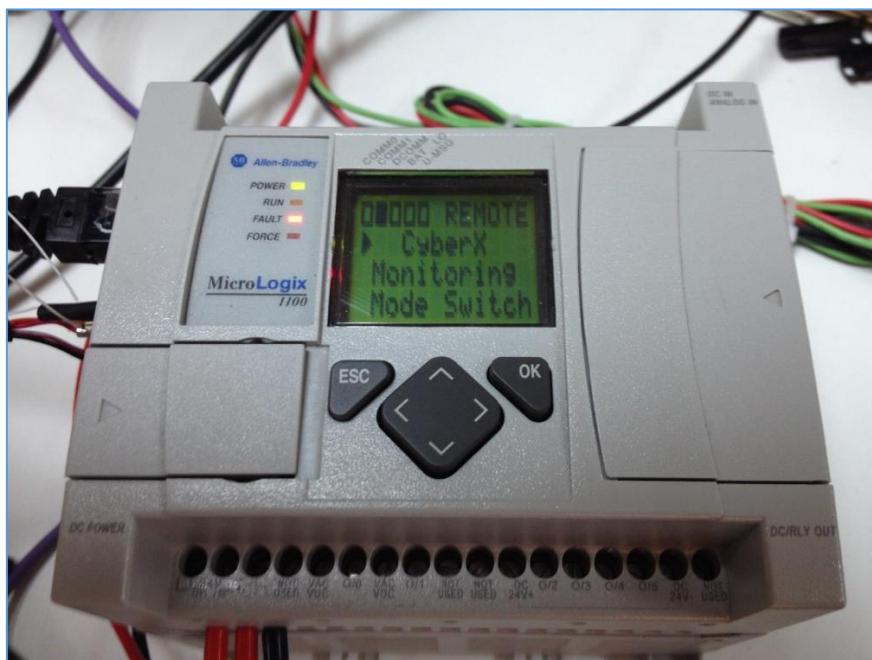
Although there might be other ways, the easiest way to send our shellcode along with the exploit was to place it in the URI as an argument, since all of the arguments are parsed and placed into a constant address in the memory. The shellcode we have written prints the word " CyberX " as part of the PLC's menu. The images below display the PLC's menu before and after the execution of our exploit.

After running the POC
